# 15 January 2022 Volcanic Eruption and Tsunami. Preliminary Satellite-Based Comprehensive Damage Assessment Report

Tongatapu, Eua, and Ha'apai divisions of the Kingdom of Tonga

The 4<sup>th</sup> of February 2022

Prepared By  
United Nations Satellite Centre (UNOSAT)

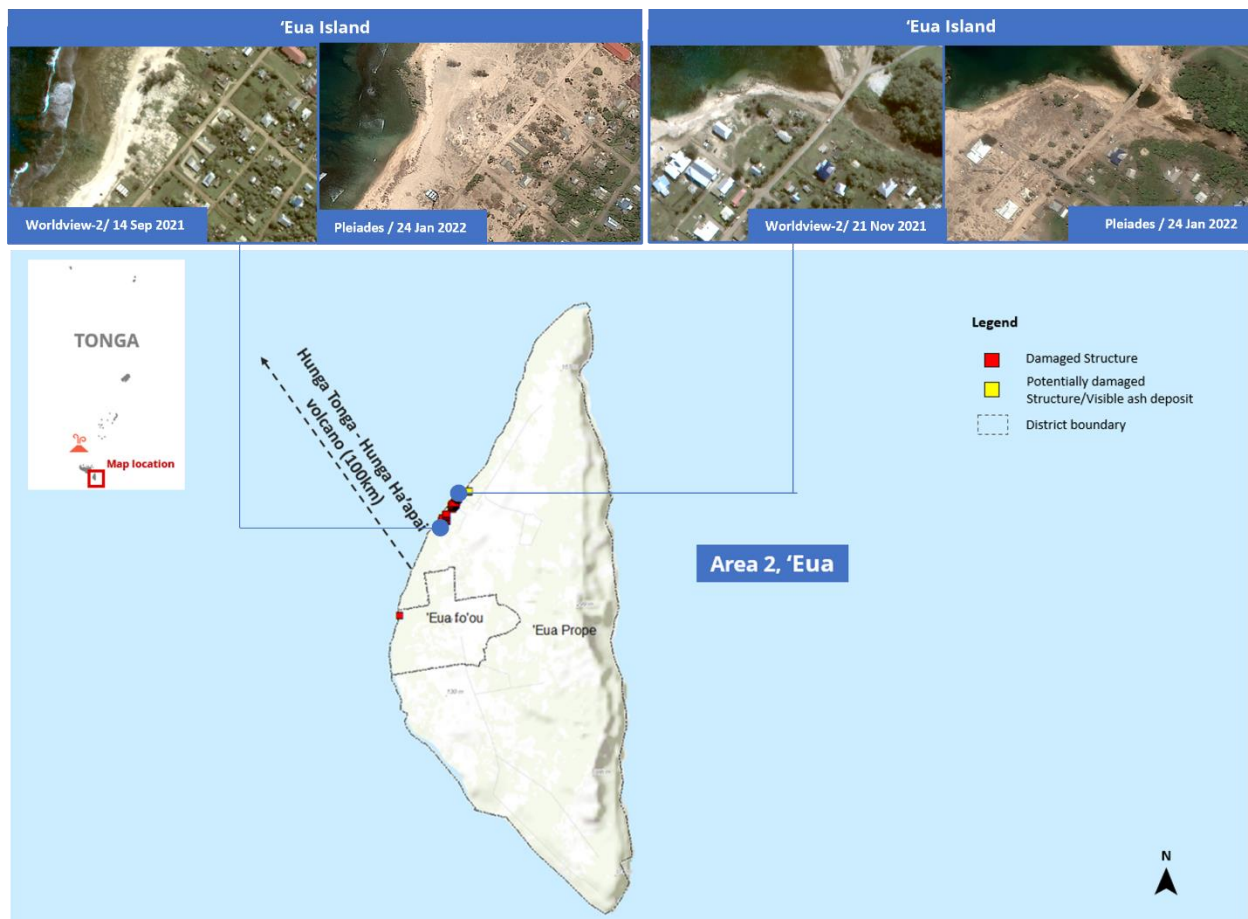
Preliminary building/structure damage assessment was conducted through visual interpretation by UNOSAT and partners utilizing before and after very high-resolution satellite imagery. The post-disaster satellite images were acquired after the volcanic eruption on 15 January 2021 with available pre-disaster images. A total of 140 buildings were identified to have suffered prominent visible damages and ash deposits within the analysed areas. Eua Prope district had the highest number of affected buildings, with over 139 damaged buildings detected.

Figure 7. This map depicts damaged buildings in the 'Eua Division of Tonga. Additional inset images from the WorldView-2 and Pleiades satellites acquired before and after the volcanic eruption on 15 January 2022 highlight and visualise the extent of damage to buildings within 'Eua Island.
